# Technical Bulletin

Symmetry™ EN-1DBC+ / EN-2DBC V1.05 Firmware  
October 2017

## EN-1DBC+ / EN-2DBC Firmware

9601-0172 Issue 1.0

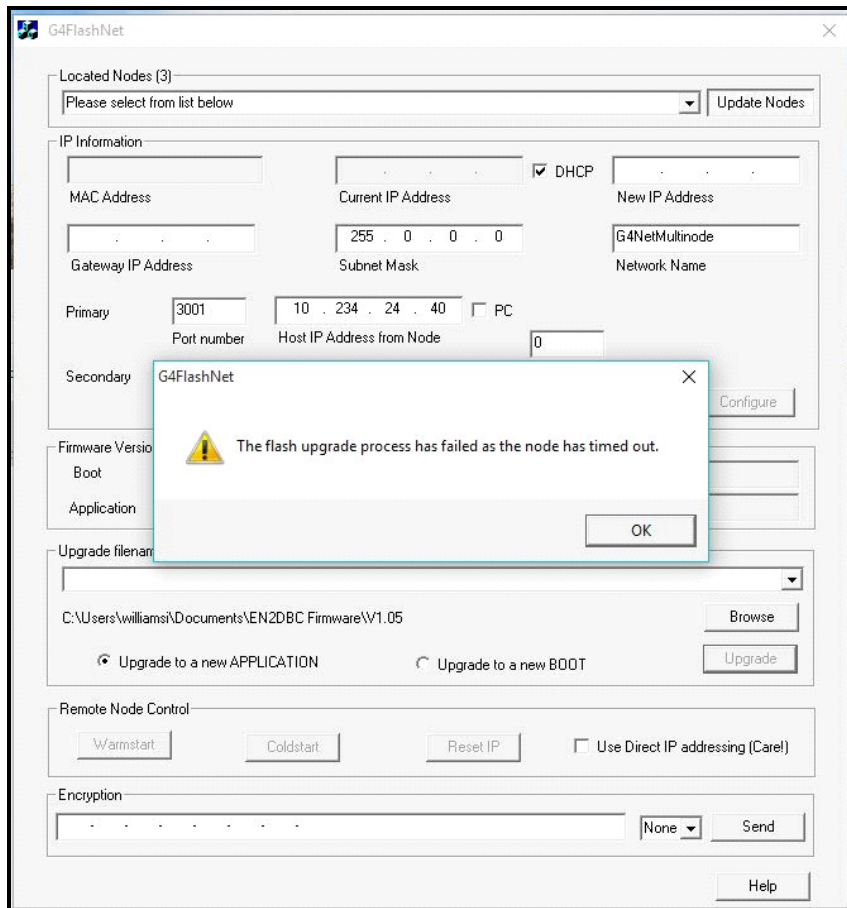
Fig 6, flash upgrade timeout screen:

Due to configuration and timing constraints within the node the 'Upgrade' will fail on the first attempt, the message 'The flash upgrade process has failed as the node has timed out' will be displayed, see fig 6.

This is expected behaviour, click 'ok' on the error message, re-start the process by reselecting the firmware file and clicking the 'upgrade' button. When the firmware has been upgraded the message 'The flash upgrade has been done' will be displayed. See fig 7.
