Technical Bulletin

Symmetry™ EN1DBC+ / EN2DBC Firmware
November 2022

This bulletin provides information for the release of V1.07 firmware for the EN1DBC+ / EN2DBC.

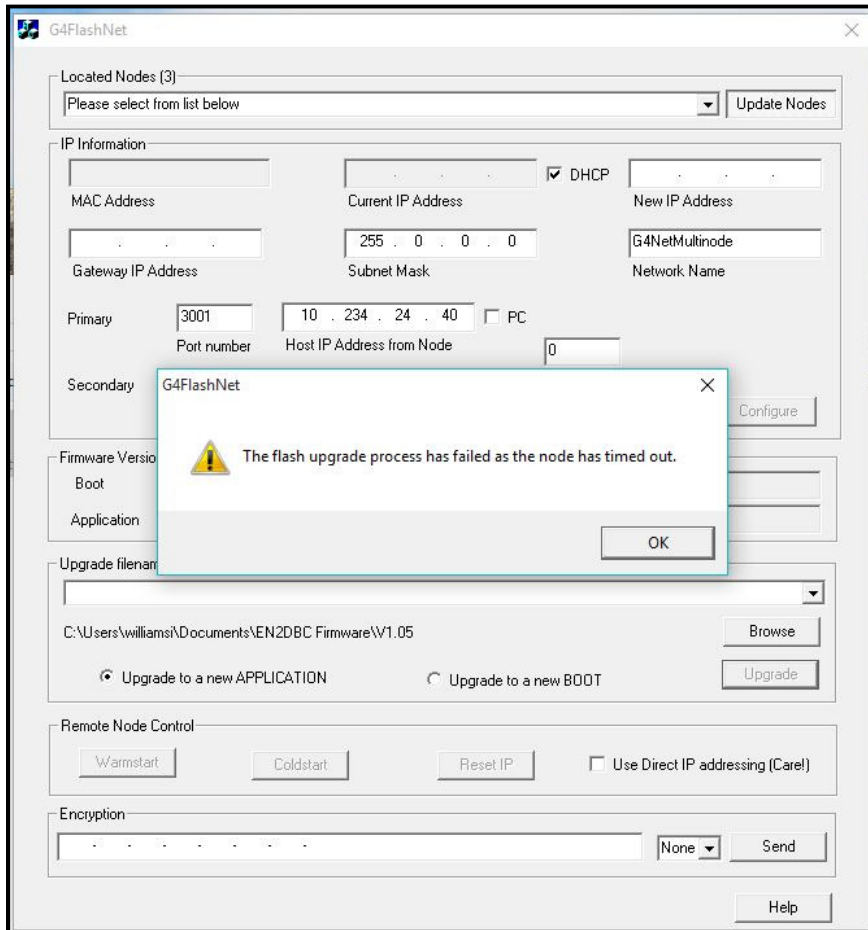
Fig 6, flash upgrade timeout screen:

Owing to configuration and timing constraints within the node the 'Upgrade' will often fail on the first attempt, the message 'The flash upgrade process has failed as the node has timed out' will be displayed, see fig 6.

This is expected behaviour, click 'OK' on the error message, re-start the process by reselecting the firmware file and clicking the 'Upgrade' button.
